NRDL-TR-28-109

623435
SEAWATER CORROSION STUDIES OF SNAP-21 MATERIALS

**U.S. NAVAL RADIOLOGICAL
DEFENSE LABORATORY**

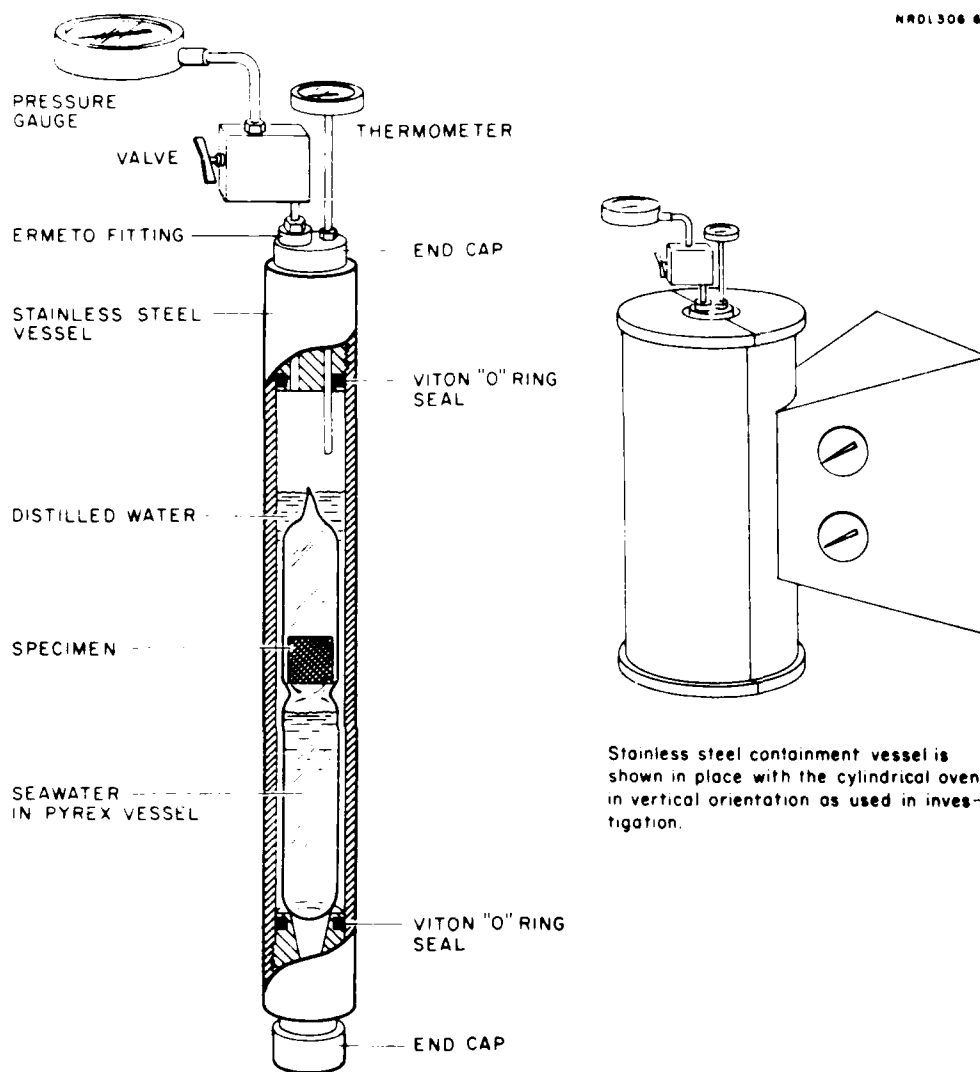
Fig. 1 Exposure Apparatus Used in Hot-Seawater-Vapor Experiment.

The apparatus used to expose test specimens to hot seawater vapor consisted of two vessels, one within the other (Fig. 1). The inner vessel, a sealed pyrex tube, held one test specimen and the test seawater; the outer vessel, made of stainless steel, held the pyrex vessel and some distilled water. The pyrex tube had a circumferential indentation on which the specimen rested, the seawater level being below this indentation. This arrangement insured that the specimen was not immersed in the seawater. The assembled exposure apparatus was placed in a cylindrical-type electrically heated oven (Hevi-Duty Electric Company, Milwaukee, Wisconsin) and heated to nominally 200°C. The temperature and pressure within the stainless steel vessel were monitored by a dial thermometer (Weston Instruments, Newark, N.J.) and a pressure gauge (Marsh Instrument Company, Skokie, Illinois), respectively. The exposure apparatus was designed to provide a very large pressure safety factor. The pyrex vessel which contained the radioactive specimen had nominal dimensions of 20 mm OD, 1.2 mm wall thickness and 12 cm length. The recommended maximum working pressure for a pyrex vessel of these dimensions is reported to be 500 psi.⁴ The pyrex vessel, however, would not experience much of a pressure differential. The stainless steel vessel, with dimensions of 3.175 cm OD and 21.6 cm length, had a pressure rating of 10,000 psi at a working temperature of 200°C.* High-pressure stainless steel tubing and "Ermeto" fittings,

rated at 15,000 psi, were used to introduce the pressure gauge and thermometer stem to the interior of the stainless steel vessel. For minimization of the radiation hazard to personnel the entire apparatus was placed in a lead cave.

The experimental procedures used in making a run were as follows. The pyrex tube was filled up to just below the circumferential indentation with seawater, the radioactive specimen put into the pyrex tube, and the pyrex tube flame-sealed under vacuum. After cooling to room temperature the pyrex tube was inserted into the stainless-steel pressure vessel, distilled water added to partly fill the vessel, and the end cap screwed on. The cylindrical oven in which the pressure vessel was placed was oriented in the vertical position (Fig. 1). After an exposure period was completed the pressure vessel was removed from the oven and allowed to cool to room temperature. After cooling, the end cap of the pressure vessel was unscrewed, and the pyrex tube was removed and placed into a hole drilled in a lead block.

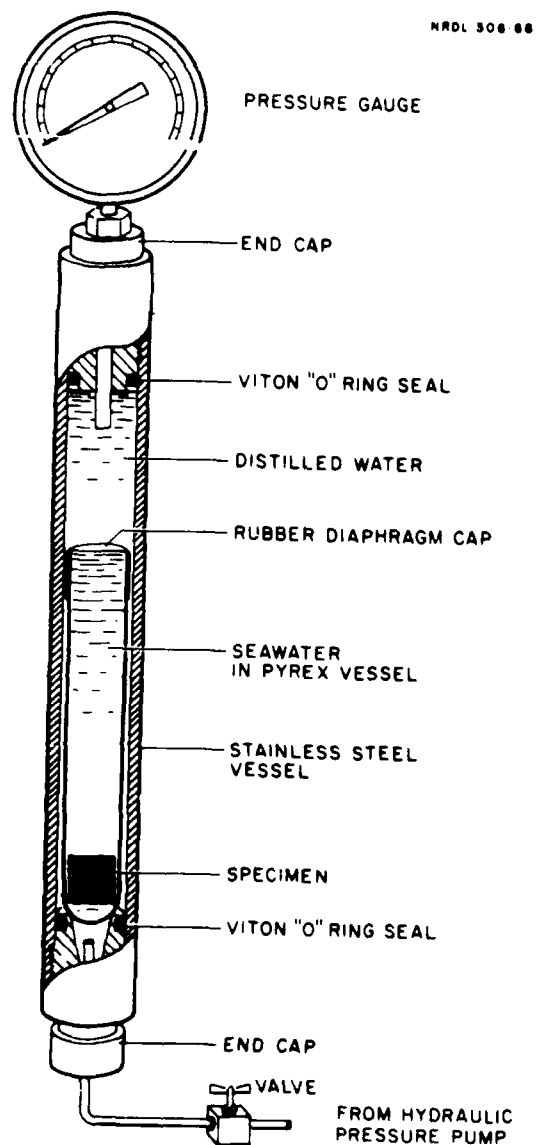
Fig. 2 Exposure Apparatus Used in High-Hydrostatic-Pressure Experiment.

The apparatus and procedure used to expose specimens to a high hydrostatic pressure (Fig. 2) was similar to that used for the hot-vapor experiment. The inner pyrex tube, which held the specimen, was completely filled with seawater and a thin, tight-fitting rubber finger (a finger cut from a surgeon's rubber glove) was slipped over the open top to seal it. The filled pyrex tube was then inserted into the stainless steel pressure vessel (the same type as used in the hot-vapor experiment), the pressure vessel filled completely with distilled water, and the hydrostatic pressure inside the pressure vessel raised to 7000 psi by means of an air-operated hydraulic power unit (Sprague Engineering, Model S-216 CR, Gardena, California). A 0-7500 psi pressure gauge (Autoclave Engineers, Inc., Erie, Pa.) was used to monitor the pressure. This hydrostatic pressure was transmitted to the interior of the pyrex tube via the thin rubber covering over the open end of the tube. This experiment was carried out at ambient room temperature (ca. 23°C).

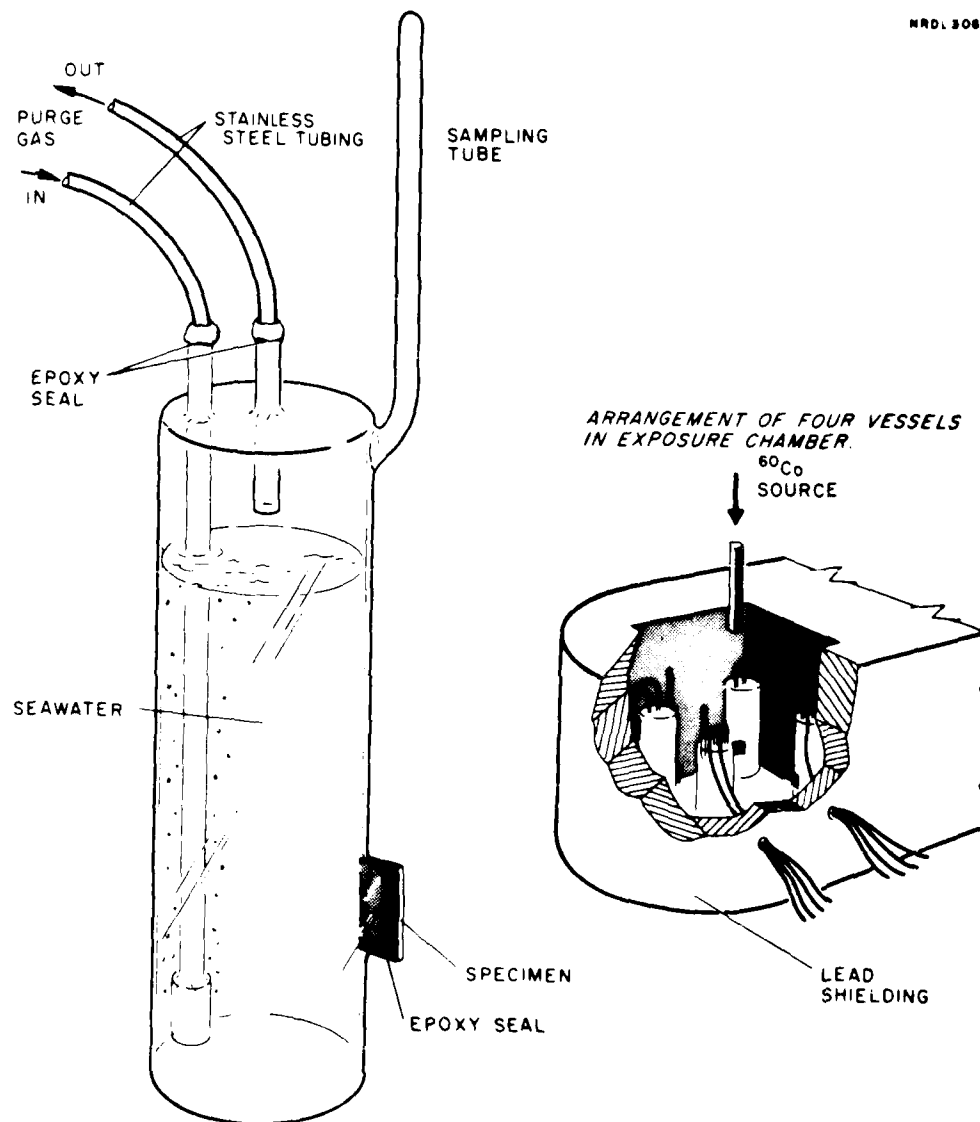
Fig. 3 Exposure Apparatus Used in Cobalt-60 Gamma-Ray Experiment.

The test specimen was placed in an exposure configuration such that one side of the specimen was in contact with seawater while the ionizing radiation from the cobalt-60 gamma ray source impinged on the dry (other) side. This exposure configuration was achieved by the specimen's being epoxied over a hole on the outside wall of a cylindrical pyrex jug (Fig. 3). Two tubulations on the top of the jug served as the inlet and outlet for the test gas, either air or nitrogen. The inlet tube had a fritted pyrex bubbler on the end that extended to the bottom of the pyrex jug. Stainless steel tubing was epoxied to the ends of the inlet and outlet tubulations and the tubing was routed out of the irradiation cavity of the cobalt-60 source through a hole in the bottom of the cavity. The exhaust tubing terminated just outside of the irradiation cavity while the inlet tubing was attached to the source of test gas. The inlet flow of the gas, either from an air or nitrogen tank, was controlled by a regulator valve and a flow meter, in that order. A third tubulation on the top of the pyrex jug served as a filling and sampling tube. It extended approximately 8 cm from the top of the jug.

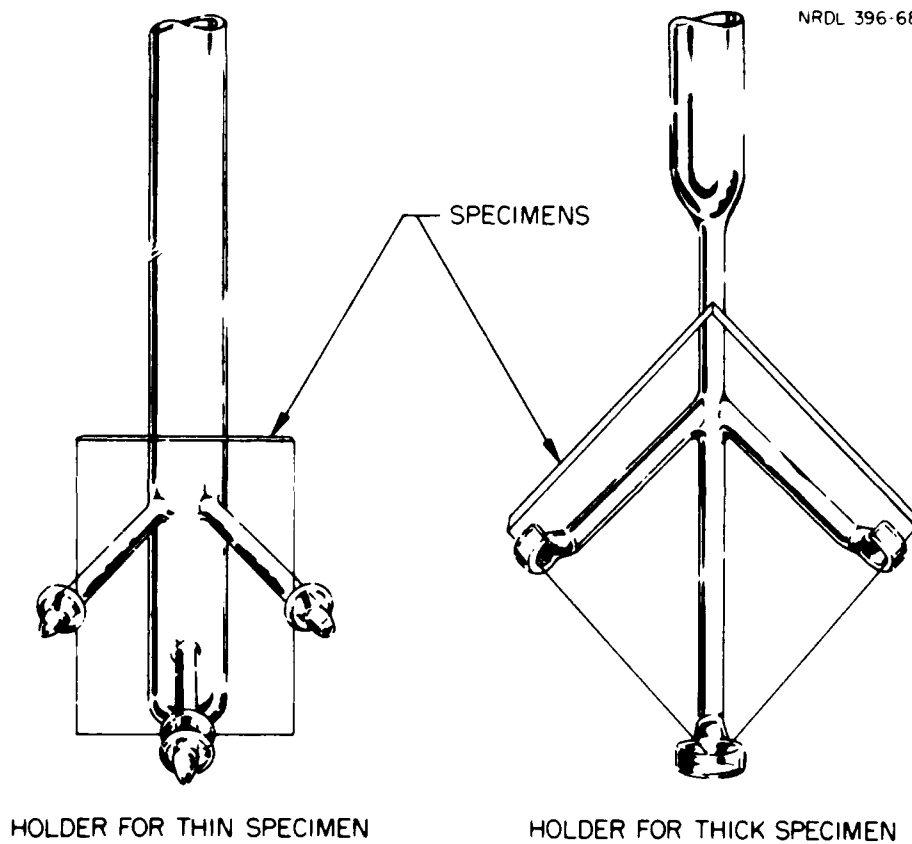
Fig. 4 Pyrex Holders for Thin and Thick Berylco-165 Specimens.

Specimens of Berylco-165 (not radioactive) were immersed in 1 liter of seawater contained in a pyrex flask. The specimens were held in pyrex holders (Fig. 4). The conditions of exposure were the same as those for the radioactive specimens. At successive intervals of 9, 18, 31, 40, 37 and 48 days (total elapsed exposure times of 9, 27, 58, 98, 135 and 183 days) the seawater in which the thin Berylco-165 specimens had been immersed was removed from the pyrex flasks and replaced with fresh seawater. For the thick Berylco-165 specimens the sampling intervals were 40, 36 and 48 days (total elapsed exposure times of 40, 76 and 124 days). The seawater from each exposure interval was assayed⁶ for copper content.

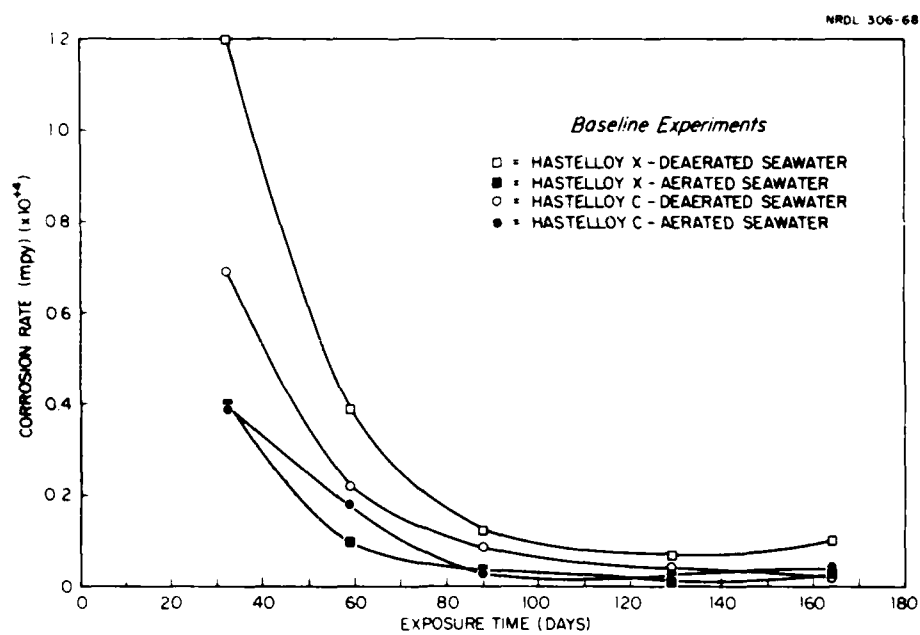
Fig. 5 Corrosion Rates of Hastelloy X and Hastelloy C in Seawater - Baseline Values.

Figure 5 shows the corrosion rates of Hastelloy C and Hastelloy X in aerated and deaerated seawater as a function of exposure time. It should be noted that the individual data points in Fig. 5, as in all of the figures to follow, represent not instantaneous corrosion rates but rather the average value over a particular exposure interval. All of the corrosion rates decreased to relatively constant values after about 100 days. There appears to be no significant difference between corrosion rates measured in aerated and those in deaerated seawater at the longer exposure times.

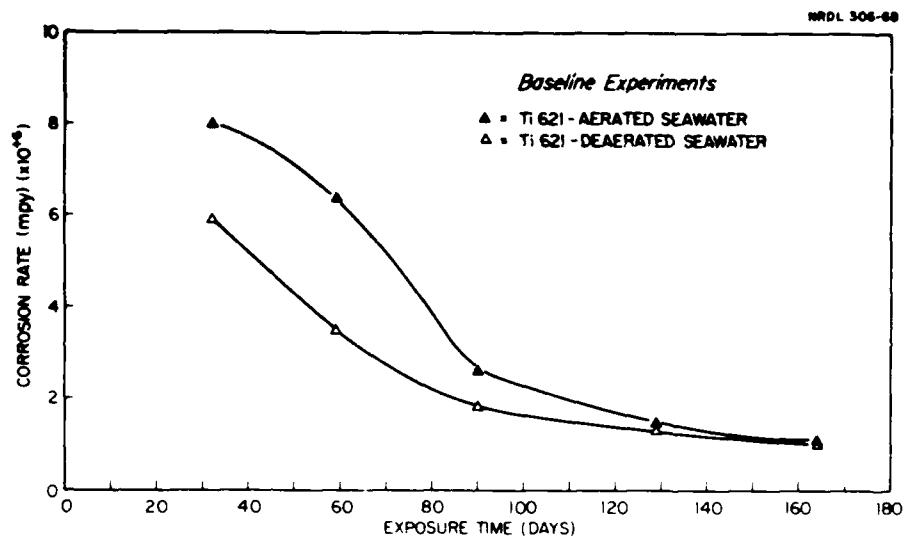
Fig. 6 Corrosion Rates of Titanium-621 Alloy in Seawater - Baseline Values.

Figure 6 shows the corrosion rates of titanium-621 alloy in aerated and deaerated seawater as a function of exposure time. As in the case of the Hastelloy alloys, the corrosion rates decreased with time and there was no significant difference between the corrosion rate measured in aerated and that in deaerated seawater.

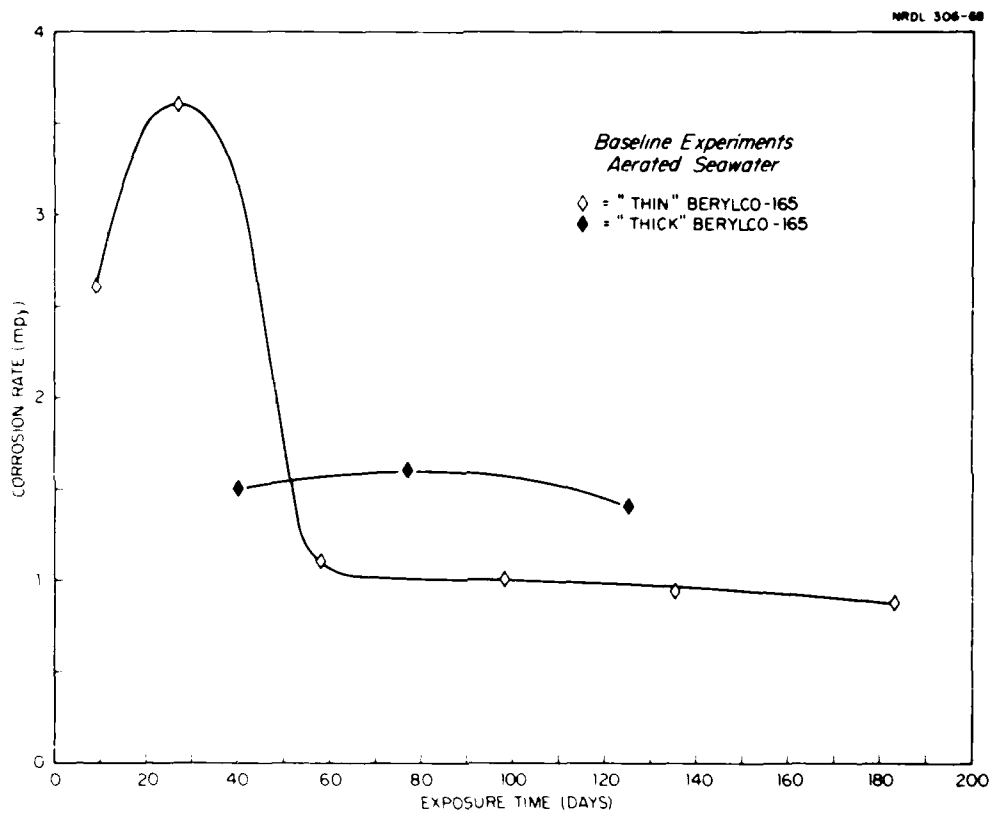
Fig. 7 Corrosion Rates of Berylco-165 Alloy in Aerated Seawater - Baseline Values.

Figures 7 and 8 show the corrosion rates of the thin and thick Berylco-165 specimens in aerated and deaerated seawater, respectively, as a function of exposure time. There was a considerable difference in corrosion behavior between specimens immersed in aerated seawater and those immersed in deaerated seawater. In aerated seawater the area of the specimen which was in contact with the pyrex holder suffered relatively severe attack while the remaining areas not in contact with the holder corroded more uniformly. In deaerated seawater there was very little local attack at the pyrex-specimen interface; the entire area of the specimen corroded uniformly. Because of the non-uniformity of corrosion of the specimens in aerated seawater the corrosion rates in aerated seawater (Fig. 7) are not as meaningful as those in deaerated seawater (Fig. 8). (All corrosion rates reported here are calculated on the basis of uniform corrosion.) The initial "peak" in the corrosion rate of the thin Berylco-165 specimen shown in Fig. 7 very likely reflects the sharp increase in corrosion rate due to initiation of the severe attack shown in Fig. 9. The cause of the increased corrosion in aerated seawater is most likely due to the presence of carbonic

acid (from the carbon dioxide in air) which dissolves the protective surface oxide film⁵ followed by formation of oxidation cells between oxygen-rich and oxygen-deficient areas (crevices), the latter areas becoming anodic.

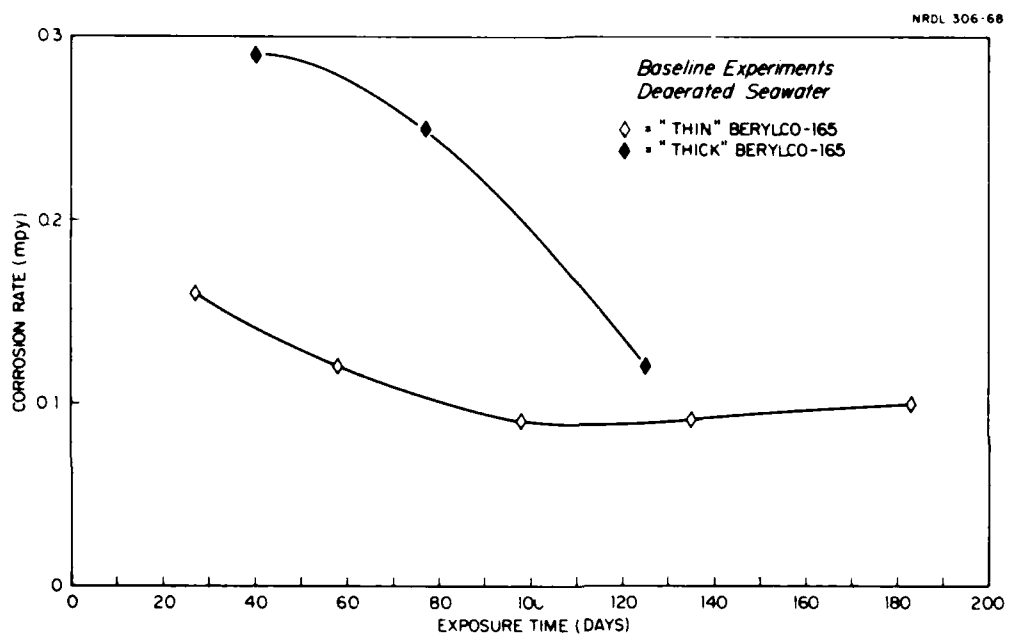
Fig. 8 Corrosion Rates of Beryllco-165 Alloy in Deaerated Seawater - Baseline Values.

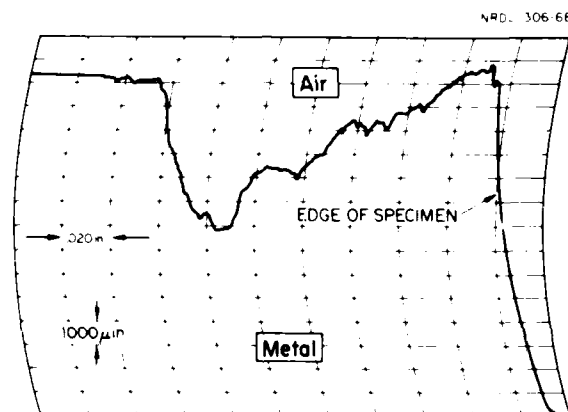
Fig. 11 Surface Profile of Local Corrosion on the Thin Beryllco-165 Specimen Shown in Fig. 9.

Figures 9 and 10 show photographs of the thin and thick Berylco-165 specimens, respectively, which had been immersed in aerated seawater (thin specimen - 183 days exposure, thick specimen - 124 days exposure). The presence of localized corrosion is evident in these photographs and the extent of corrosion is illustrated further in Figs. 11 and 12, which show the surface profiles of the areas of local corrosion (the arrows on the photographs indicate the approximate path of the proficorder sensing element). Figures 13 and 14 show a photograph and surface profile, respectively, of a representative area of the thick Berylco specimen which had been immersed in deaerated seawater for 124 days. The abrupt change in the profile in Fig. 14 is caused by a scale change on the proficorder. It is evident that the corrosion is much more uniform on this specimen.

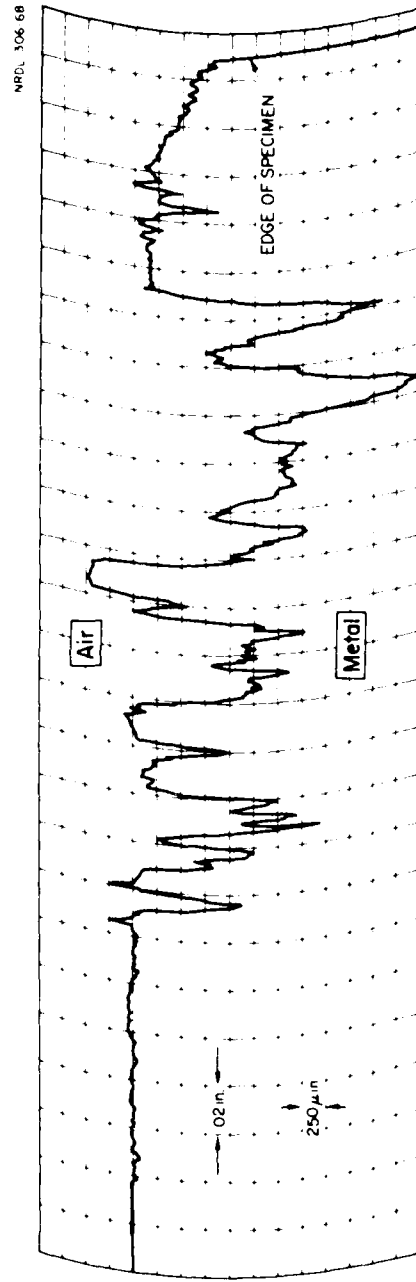
Fig. 12 Surface Profile of Local Corrosion on the Thick Berylco-165 Specimen Shown in Fig. 10.

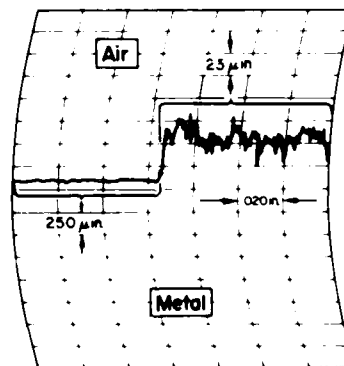
Fig. 14 Surface Profile of Thick Beryllco-165 Specimen Shown in Fig. 13.

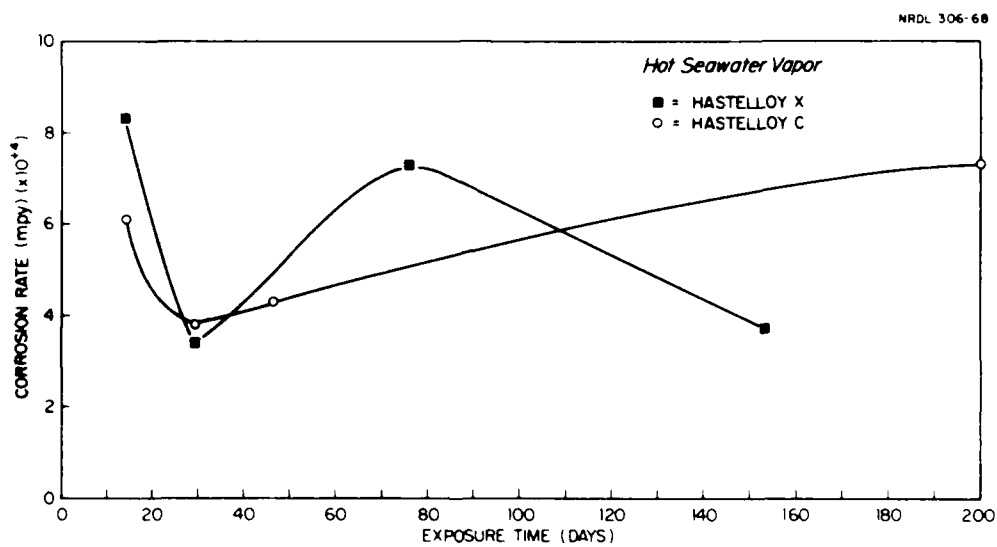
Fig. 20 Corrosion Rates of Hastelloy X and Hastelloy C in a Hot-Seawater-Vapor Environment.

Figure 20 shows the corrosion rates of Hastelloy X and Hastelloy C in hot seawater vapor as a function of exposure time. The data points for several exposure periods are missing due to cracking of the pyrex vessel (and hence loss of the seawater sample) during these exposure periods. There appears to be no significant difference between the

corrosion rates of Hastelloy C and Hastelloy X. The corrosion rates were relatively constant (within a factor of about two) during the duration of the experiment, the nominal value being about 5×10^{-4} mpy. This value is between one and two orders of magnitude greater than the values obtained in the baseline experiment (approximately 2×10^{-6} mpy for Hastelloy C and 1×10^{-5} mpy for Hastelloy X in deaerated seawater).

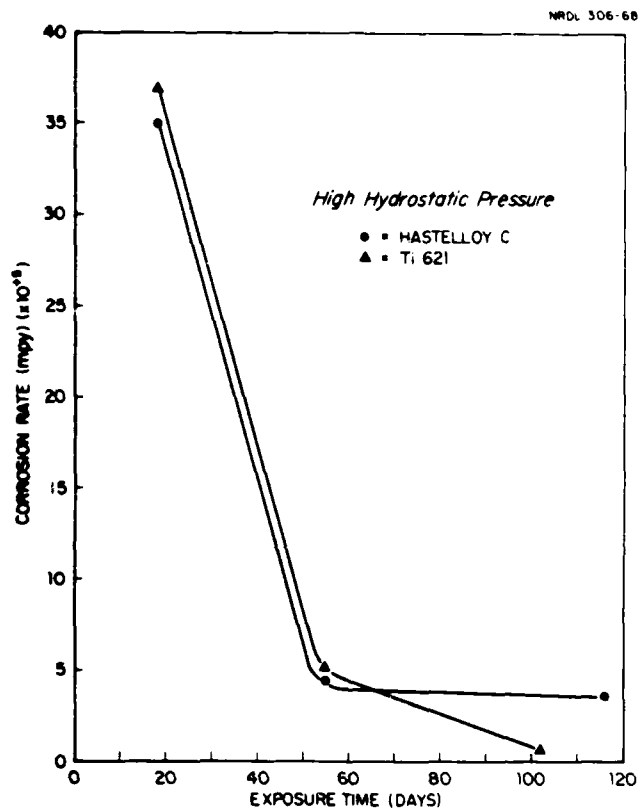
Fig. 21 Corrosion Rates of Hastelloy C and Titanium-621 Alloy in Seawater Under High Hydrostatic Pressure.

Figure 21 shows the corrosion rates of Hastelloy C and titanium-621 alloy in seawater at a hydrostatic pressure of 7000 psi. The corrosion rate of both alloys decreased rapidly. The corrosion rate of titanium-621 at high pressure is about a factor of 3 higher than the baseline corrosion rate. The corrosion rate of Hastelloy C at high pressure is about an order of magnitude higher than the baseline value.

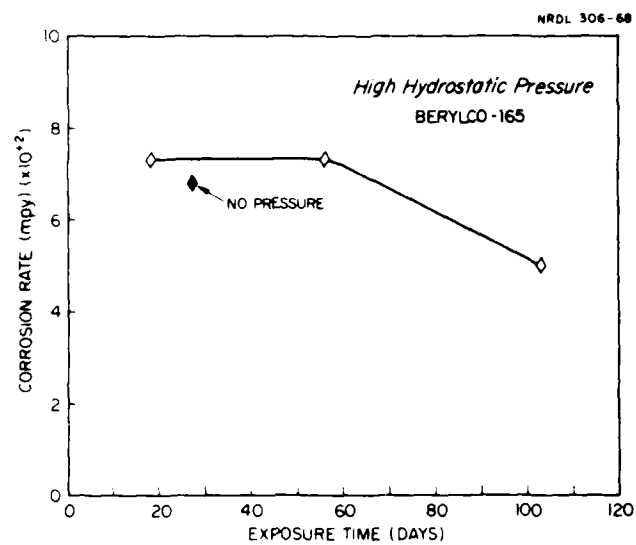
Fig. 22 Corrosion Rate of a Thin Berylco-165 Specimen in Seawater Under High Hydrostatic Pressure.

Figure 22 shows the corrosion rate of Berylco-165 in seawater at a hydrostatic pressure of 7000 psi. The corrosion rate was relatively constant, being 5×10^{-2} mpy at the end of 103 days. This value can be compared to the value obtained on the thin Berylco-165 specimens, 9×10^{-2} mpy, in the baseline experiments (the smaller specimens used in the high-pressure experiment were cut from the thin Berylco-165 specimens). The deaerated seawater baseline value was used for comparison since it would be expected that the oxygen and/or carbon dioxide would become depleted in the relatively small volume of seawater (nominally 20 cc) in the pyrex vessel used for the high-pressure experiments. As an additional point of reference a specimen of Berylco-165 was run with the identical apparatus and procedure as was used in the high-pressure runs except that the seawater was not pressurized. This data point is shown in Fig. 22. It is evident that there is no significant effect of high hydrostatic pressure on the corrosion rate of Berylco-165 up to a pressure of 7000 psi.

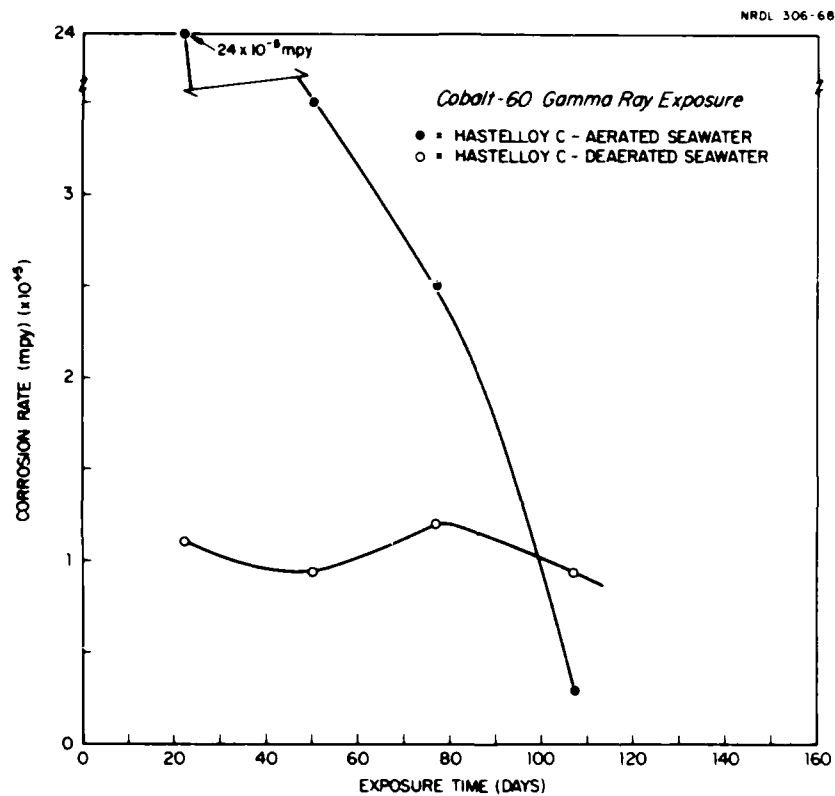
Fig. 23 Corrosion Rates of Hastelloy C in Seawater in an Ionizing Radiation Field.

Figures 23 and 24 show the corrosion rates of Hastelloy C and Hastelloy X, respectively, in aerated and deaerated seawater in an ionizing radiation field. The corrosion rate of Hastelloy C in deaerated seawater is relatively constant, being nominally 1×10^{-5} mpy. This value is about twice the baseline value, 6×10^{-6} mpy. In aerated seawater the corrosion rate after 107 days was 3×10^{-6} mpy and decreasing. This value compares well with the baseline value of 2×10^{-6} mpy. The behavior of Hastelloy X is similar to that of Hastelloy C. In both environments there appears to be no significant effect of ionizing radiation on the corrosion rates of these alloys for the dose range used in these experiments.

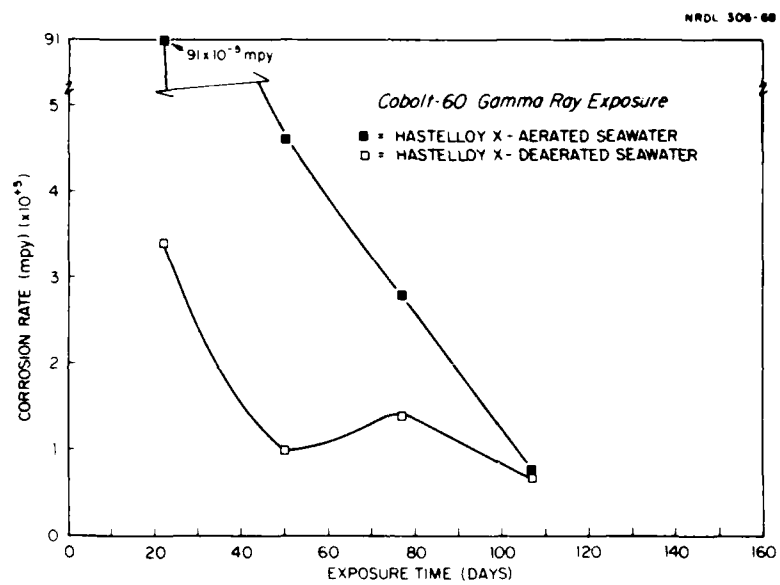
Fig. 24 Corrosion Rates of Hastelloy X in Seawater in an Ionizing Radiation Field.
